Hughes Warehouse Adaptive Reuse

Project Overview

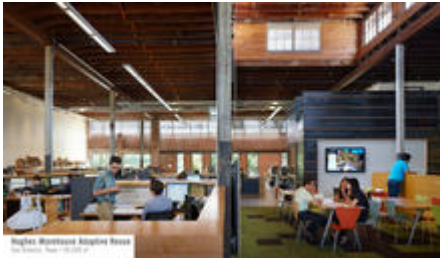
Inspired by the history of the Hughes Plumbing Warehouse, this adaptive reuse project transforms an early 20th-century warehouse into an innovative but functional studio space. The renovation preserves the openness and industrial character of the original building, maintaining its expansive 18-ft ceilings and preexisting structural grid. An array of meeting spaces organized within the grid serve as the primary organizational component for the studio, a strategy that has enhanced creative collaboration and communication between staff while also facilitating project reviews, client meetings, design charrettes, and visiting student critiques.

A newly inserted 1,500-SF courtyard unfolds beyond the existing brick façade, creating an unexpected public gathering spot that opens the building to the street and provides access to adjacent tenant spaces. The existing loading dock openings are fitted with custom perforated steel gates—patterned off an abstraction of a Jackson Pollock painting—to provide cohesion with the neighboring arts and design district, and serve as a reminder of the building's graffitied past. The renovation of the warehouse along the banks of the San Antonio River in the burgeoning River North district of downtown San Antonio has transformed not only a building but an organizational culture and neighborhood.

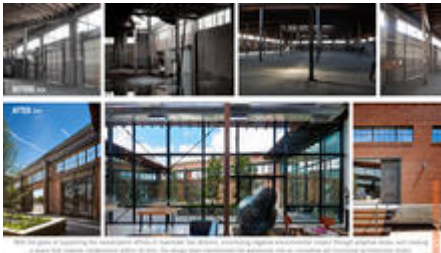
Located along a defunct railway corridor, the 1917 Hughes Plumbing Warehouse suffered from the same sprawl-driven neglect as much of its surrounding neighborhood. With the goals of supporting the revitalization efforts of downtown San Antonio, minimizing negative environmental impact through adaptive reuse, and creating a space that inspires collaboration within its firm, the design team transformed the warehouse into an architectural studio with two adjacent tenant spaces. Because these are leasable spaces, long-term flexibility was a critical driving force for the project. A collaborative programming process involving the entire firm exposed unnecessary programming features. Additionally, the balance between maintaining the historic integrity of the building and improving energy efficiency was critical for the nearly 100-year-old building. As a result, the design team focused on preserving the open plan space and leaving interventions light in order to maximize flexibility of the space for future users. This also had the effect of encouraging collaboration amongst staff and minimize material usage by eliminating private offices. Though it decreased leasable square footage, the project's newly inserted courtyard became integral to the design, providing a place for public life, improving daylighting, and decreasing the amount of conditioned space.

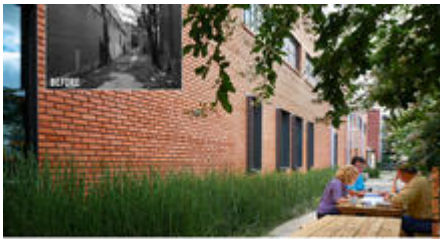
In addition to the inherent benefit that adaptive reuse provides by preserving green space, the project incorporates several strategies to enhance the site ecology, as well as strategies to positively impact the local and global communities. The original industrial site was completely paved with no green space. The design team restored a neglected alley into a xeriscaped pocket garden and work space, which features drought-tolerant, native plants that provides habitat for wildlife and concrete pavers that were repurposed from the building. Garden beds occupy approximately 25% of the courtyard area and include newly planted trees. The alley garden, located along the east side of the site, also contains planting beds for food production. Because the footprint of the building occupies virtually the entire site and because the historic building is unable to bear loads of a green roof, the firm created a carbon offset plan that incrementally builds each year over the next ten years. The plan currently offsets carbon emissions for 20% of the firm's net energy usage, after adjusting for renewable energy produced onsite, and for 100% of paper usage.

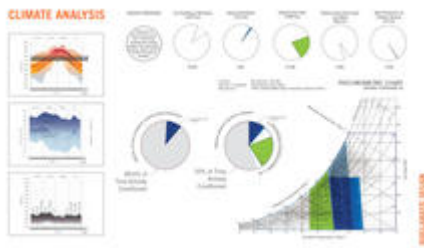
Bioclimatic Design

Honoring the history of the building, the design team left the existing double wythe brick walls mostly intact but improved thermal insulation through the addition of R20 rigid roof insulation. The roof was upgraded to a reflective TPO cool roof to mitigate heat gain. Though the original steel frames surrounding the clerestory windows would only accept 1/4-inch laminated safety glass, the new punched windows and curtain wall feature one-inch-thick Solar Band 70 XL coated high-performance glass. Steel window box shades surround the windows along the east and west facades. To mitigate solar gain, the new shades are extruded about a foot on the east side of the building, and about two feet on the west. The clerestories and courtyard curtain wall are equipped with translucent, automated shades that control glare without obscuring views and also abide by the astronomical clock. These combined shading strategies have reduced the amount of time that requires active conditioning by 18.5% per year. The courtyard curtain wall illuminates interiors but is shaded by the preexisting south façade, preventing direct glare. A 65 kW photovoltaic rooftop array generates approximately 46% of the energy needed for building operations.

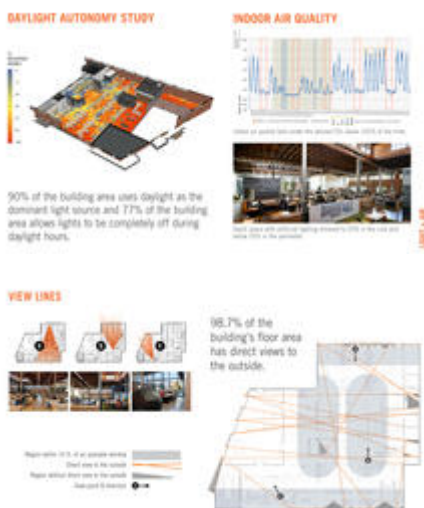
Light & Air

Other than clerestory windows and several loading dock entries, the building was entirely encased in a double wythe brick wall. While the clerestories provided daylight to the interior, they provided only views to the outside of the sky and did not facilitate the transition from streetscape to interior. By adding punched windows along the east and west facades and a glass curtain wall to the newly inserted courtyard, views to the outside are available in 98.7% of the floor area. Additionally, the clerestories, which had been painted over, were made

operable once again, providing natural ventilation to building occupants when desired. 60% of the office floor area is within 15 feet of an operable window, accessible to 48 of 77 full-time employees. CO2 meters monitor indoor air quality, which fall below the threshold for indoor CO2 levels.

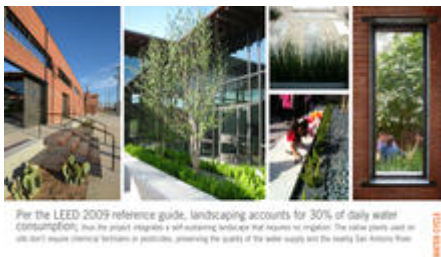
Per the LEED 2009 reference guide, landscaping accounts for 30% of daily water consumption; thus the project integrates a self-sustaining landscape that requires no irrigation. The native plants used on site don't require chemical fertilizers or pesticides, preserving the quality of the water supply and the nearby San Antonio River. All of the fixtures in the office contribute to water efficiency. Flow restrictors are found in the kitchen faucet, and electronic controls are used on all of the bathroom fixtures. Because the space is held under a 10-year lease, large-scale interventions, such as subgrade cisterns, were not possible. However, four 50-gallon rain barrels collect water on site for use in the vegetable garden and to manage onsite stormwater. Carbon credits that contribute to water projects like the lower Mississippi Alluvial Valley Reforestation Initiative have been purchased to offset 20% of the company's emissions, and company policies, such as the reuse of one-sided paper, reduces upstream water usage in manufacturing.

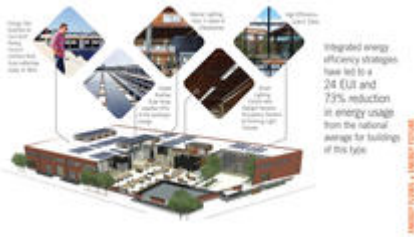
Energy Flows & Energy Future

The project integrates sophisticated systems that optimize the building's performance: shade control governed by the astronomical clock, automated lighting sensors that automatically adjust to occupancy and daylight levels, 65 kW solar panel array on the insulated roof that meet about 46% of the building's energy needs, and an HVAC system that allows individual control of each conference room. Solar power is an ideal energy source for San Antonio; as a cooling dominated climate, PVs are at their peak performance during the summer when cooling loads are at their highest. When the building is not occupied, thermostats automatically adjust a standard baseline temperature by +/- 10 degrees to reduce heating and cooling demands. These comprehensive strategies resulted in a 73% reduction from the national average.

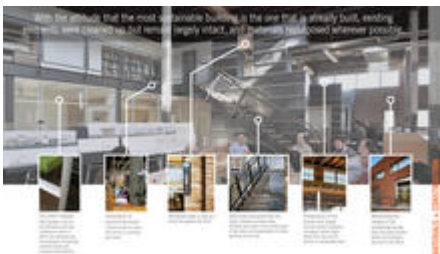
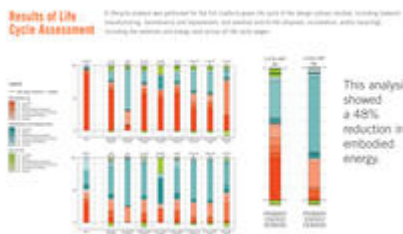
With the attitude that the most sustainable building is the one that is already built, existing elements were cleaned up but remain largely intact. The structure was left exposed to minimize material use, and materials were repurposed wherever possible. Furniture from the previous office was remilled and reassembled to create workstations that supported the open plan. Reclaimed teak was used for doors on meeting pods. Selected in part for their durability, glass and steel components—such as punched windows and a window wall overlooking the courtyard—were integrated into the existing longleaf pine and brick structure, providing natural light and ventilation to interior spaces. Timber salvaged from the roof joists was repurposed as stair treads and for board-formed concrete poured onsite. Sections of otherwise unusable concrete floor became pavers in the alley. Recycling, catering, kitchen, and green cleaning policies have been implemented, as well as a composting program for use in the alley garden.

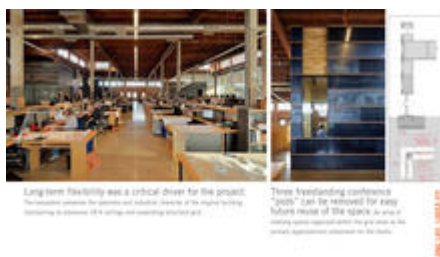
Because the tenant spaces are occupied under leasing agreements, long-term flexibility was a primary focus. The renovation preserves the building's original open plan structural grid. An array of meeting spaces organized within the grid serve as the primary organizational component for the studio. The enclosed meeting spaces consist of a bank of conference rooms at the rear, built of DIRT modular wall systems, which can be removed and reconfigured over time. Three freestanding conference "pods" function as meeting spaces, and can also be removed without altering the building's structure. In addition, none of the office furniture is built in except for kitchen cabinets. These strategies allow the space to easily be reused and reconfigured by future tenants.

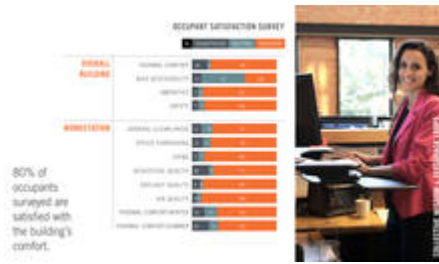
Both quantitative and qualitative feedback is used to continuously optimize the building. Building performance is tracked through CO2 monitors, as well as dataloggers that track temperature, relative humidity, and light levels. A year and a half after building occupancy, a post-occupancy survey was conducted with plans to repeat the survey annually. The survey considered the overall building experience such as thermal comfort, acoustical comfort, workstation ergonomics, bike accessibility, amenities, and safety. On average, the results showed users were 80% satisfied. The survey led to new initiatives to increase user well-being, like a bike to work program, the option for standing work desks, and improvement of bathroom amenities. Prior to construction, potential concerns about acoustics had been expressed due to the project's open spaces and hard surfaces. However, the acoustical qualities were actually quite successful, which was confirmed through the occupancy survey.

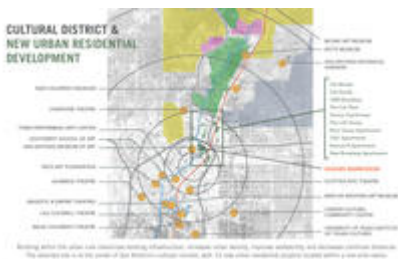
Building within the urban core, the development is located in the heart of the city, near the downtown area. The map shows the building footprint, parking area, and surrounding streets. The map also shows the location of the building relative to the downtown area.
