# Arizona State University Student Health Services

## Project Overview

The 34,000-square-foot Arizona State University Health Services Building (ASU HSB) is an adaptive reuse project that transformed the existing sterile and inefficient health clinic into a clearly organized, efficient, and welcoming facility. The design imbues the new facility with a sense of health and wellness that leverages Tempe's natural environment and contributes to a more cohesive pedestrian-oriented campus. The renovated facility, the new wing, and the entrance pavilion energize the surrounding campus by engaging the historic Palm Walk—the campus's main pedestrian spine.

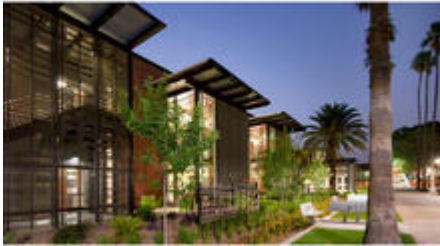
*Land Use + Site Ecology - Photo Credit: Bill Timmerman*

The design replaces 10,000 square feet of turf grass with native landscaping that strengthens the Palm Walk and provides small landscaped courts serving as reflective spaces and outdoor waiting areas. The landscaping creates a sense of privacy for both the interior and exterior clinic waiting areas. The design team was able to convince ASU to rethink their initial proposed concept in order to preserve 5,000 square feet of open green space for wellness programs.

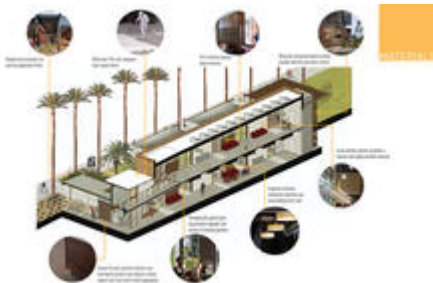
*Materials & Construction  
diagram - Photo Credit:  
Lake|Flato Architects and  
orcutt|wilson*

The first priority was to do more with less. Recycling the original Health Services Building allowed the team to reuse 76% of the existing structure. The team also eliminated extraneous finishes, exposing systems that celebrate the building while minimizing maintenance.

On the exterior, the design uses regional materials appropriate for the harsh Tempe environment and native to the campus: Brick, natural metal panel, exposed weathered steel, and stained concrete. Overhangs and screens of recycled composite wood are incorporated to protect glazing and preserve the building envelope. The screens act as armatures for vines and create a “living” building, becoming lusher over time while mitigating the thermal loads.

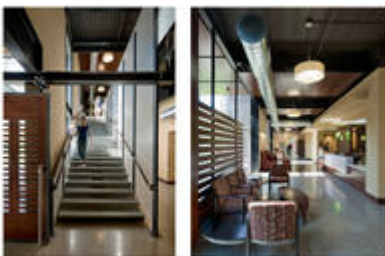
*Interior materials were  
selected to reinforce the  
building's sense of wellness  
and health - Photo Credit: Bill  
Timmerman*

Materials were also selected to reinforce the building’s sense of wellness and health. The interior palette employs natural materials, such as stained FSC certified wood screens and ceilings panels, natural earthen plaster, oiled steel plate, and ground fly-ash concrete with local earth-toned aggregate. The material selection creates calming, biophilic spaces that deinstitutionalize the facility and draw students to its wellness programs.

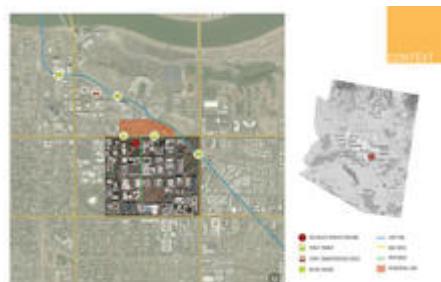
*Context plan showing how the  
project connects to its place,  
region, and neighborhood -  
Photo Credit: Lake|Flato  
Architects*
